# Influence of Prosthetic Design on Squeaking after Ceramic-on-Ceramic Total Hip Arthroplasty

Todd V. Swanson, MD • Raghavendran Seethala, MS • David J. Peterson, PharmD, DO • Ryan Bliss, BBA • Calvin Spellmon, BS • Las Vegas, Nevada

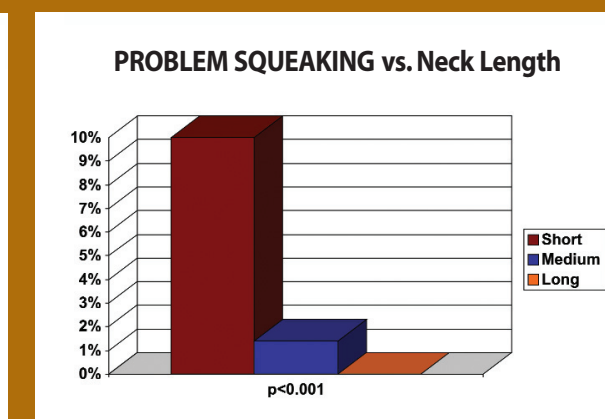
Grade (1-4)	Stryker	*Plus	Encore	Wright
4: Daily	5	2	0	0
3: >4/week	1	1	0	0
2: 1-4/week	1	1	2	0
1: <1/week	9	0	1	1

Acetabular Implant	Number of Squeakers	Number of Implants	Incidence
Stryker	16	45	35.6%
*Plus	4	58	6.9%
Encore	3	138	2.2%
Wright	1	29	3.4%
Total	24	270	8.8%

Grade (1-4)	Stryker	*Plus	Encore	Wright
4: Creates Social Problem	4	0	0	0
3: Always Perceptible to Others	4	1	0	0
2: Seldom Perceptible to Others	5	2	1	0
1: Perceptible Only to Patient	3	1	2	1

Acetabular Implant	Number of Squeakers	Number of Implants	Incidence
Stryker	5	45	11.1%
*Plus	1	58	1.7%
Encore	0	138	0
Wright	0	29	0
Total	6	270	2.2%

Incidence of Squeaking	24/270 (8.8%)
Mean time to Squeaking	19.6±19.7 months (1-65 months)

Incidence of PROBLEM SQUEAKING	6/270 (2.2%)
Mean Time to PROBLEM SQUEAKING	22.4±21.4 months (8-72 months)
