# Hip Resurfacing Arthroplasty

*J Am Acad Orthop Surg* 2006;14:454-463

Hip resurfacing arthroplasty is a type of hip replacement that involves capping the femoral head and preserving bone of the proximal femur. Metal-on-metal surface replacements have been manufactured since the early 1990s. Recent studies indicate excellent clinical results with low failure rates at 1- to 5-year follow-up. Although these early results are encouraging, resurfacing devices must be used with caution because less is known about their long-term safety and efficacy. The best candidates for resurfacing are patients younger than age 60 years with good bone stock. The surgical approach is similar to that for standard total hip replacements, but with slightly more dissection because the femoral head must be preserved and displaced to visualize the acetabulum. To reduce complications, resurfacing arthroplasty should be performed by surgeons who have received training specifically in this technique.

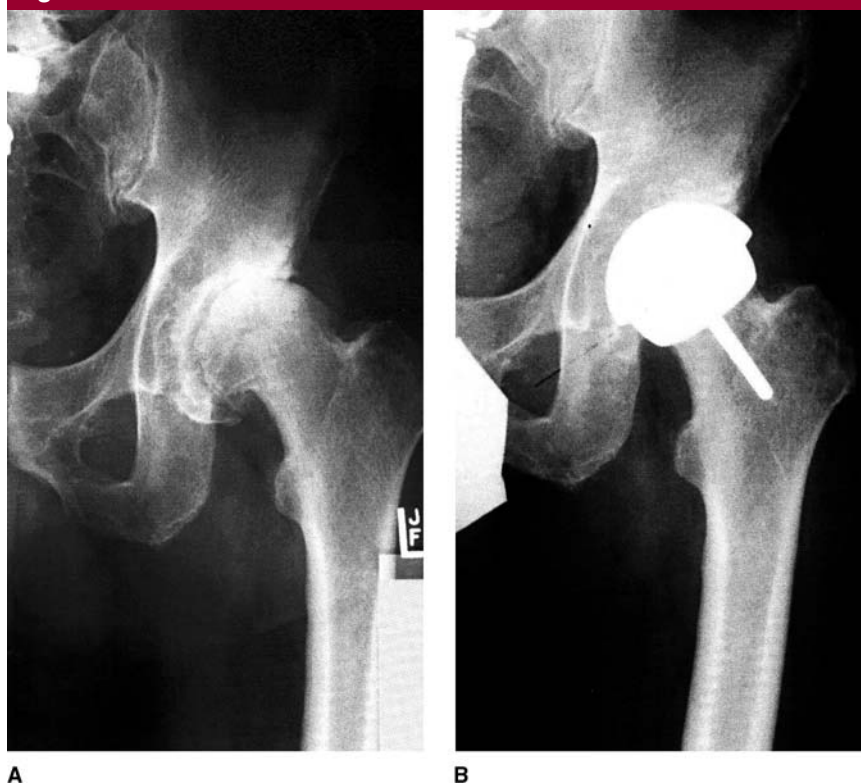
**Figure 1**

Preoperative (A) and postoperative (B) anteroposterior radiographs of a metal-on-metal resurfacing hip arthroplasty in a 46-year-old man who was treated for primary osteoarthritis.

faces has less frequently been used as a means of total hip arthroplasty (THA), however (Figure 1). Resurfacing has several theoretic advantages.

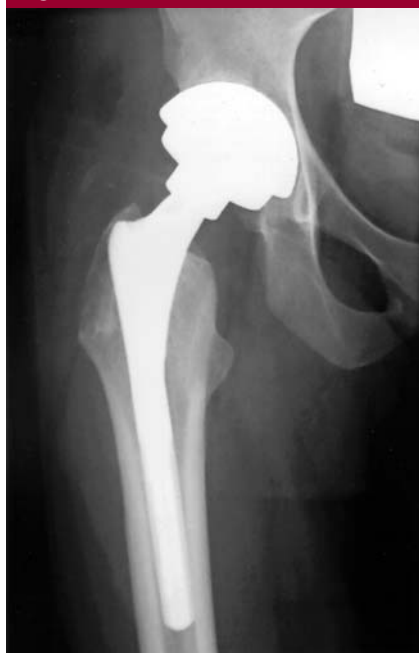
**Figure 2**

Postoperative anteroposterior radiograph of a Big Femoral Head prosthesis (Wright Medical Technology, Arlington, TN). Note the large femoral head on a standard stem, which is mated with a resurfacing acetabular component.

dition, periprosthetic bone loss, which was often extensive with polyethylene acetabular resurfacing components, may be markedly reduced with metal-on-metal bearings. With early polyethylene acetabular resurfacing components, much bone was removed during insertion. Contemporary components have a metal acetabular bearing that requires removal of little acetabular bone stock. With femoral side failure, the acetabular component can be left in place and mated to a standard femoral component with a large-diameter femoral head<sup>12</sup> (Figure 2).

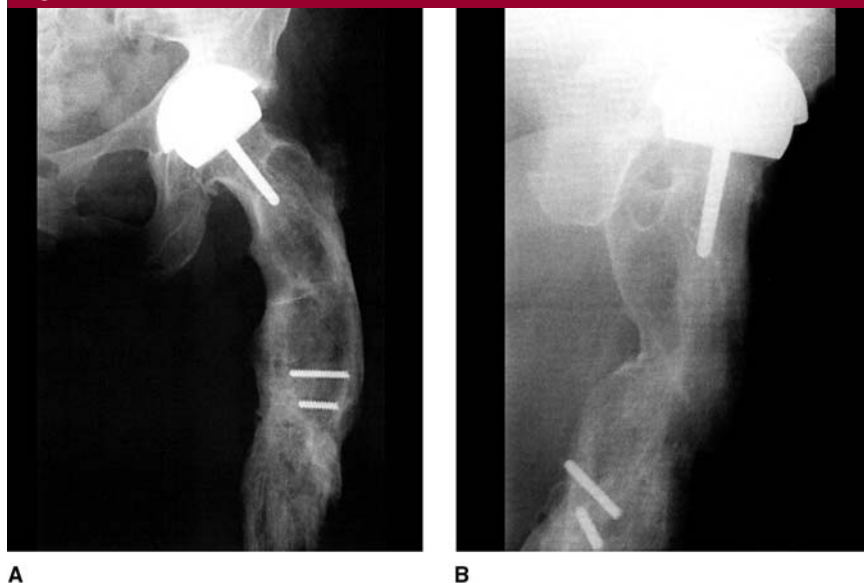
**Figure 7**

Postoperative anteroposterior (A) and lateral (B) radiographs of a patient with posttraumatic extra-articular proximal femoral deformity secondary to trauma, who was treated with resurfacing hip arthroplasty.

prostheses difficult to place (Figure 7); (2) patients with a high risk of sepsis because of prior infection or immunosuppression; and (3) patients with a neuromuscular disorder. (A large-diameter ball reduces dislocation risk in patients with a neuromuscular disorder). Based on our experience, two other excellent indications for resurfacing are (1) retained hardware that would be difficult to remove for a standard stem placement (Figure 8), and (2) patients with conditions with a high risk for failure using standard THAs (eg, sickle cell disease; alcoholism, which has a high dislocation rate).

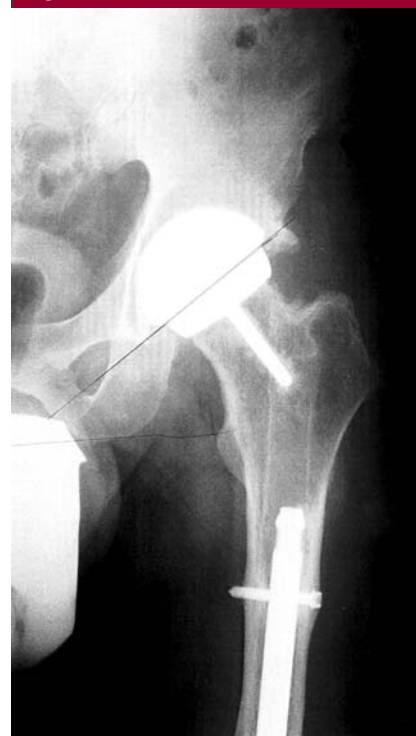
**Figure 8**

Postoperative anteroposterior radiograph of a patient in whom an intramedullary rod was placed to correct a bowing deformity of the femur. The patient underwent hip resurfacing rather than a conventional total hip replacement to avoid removal of the femoral intramedullary rod.
