Influence of Prosthetic Design on Squeaking after Ceramic-on-Ceramic Total Hip Arthroplasty

Todd V. Swanson, MD • Raghavendran Seethala, MS • David J. Peterson, PharmD, DO • Ryan Bliss, BBA • Calvin Spellmon, BS • Las Vegas, Nevada

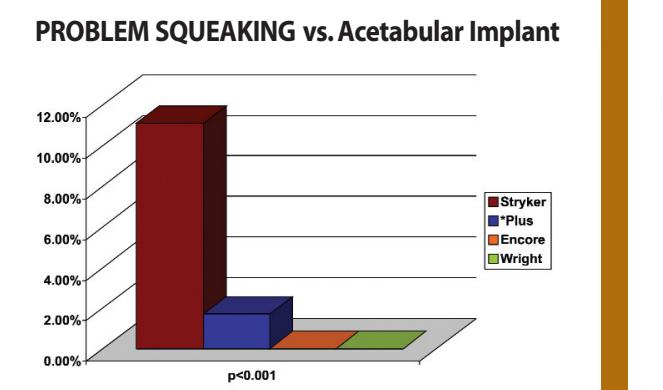
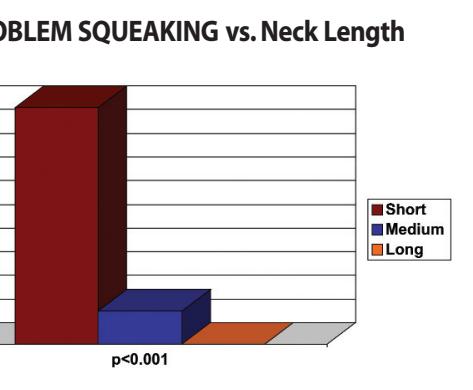
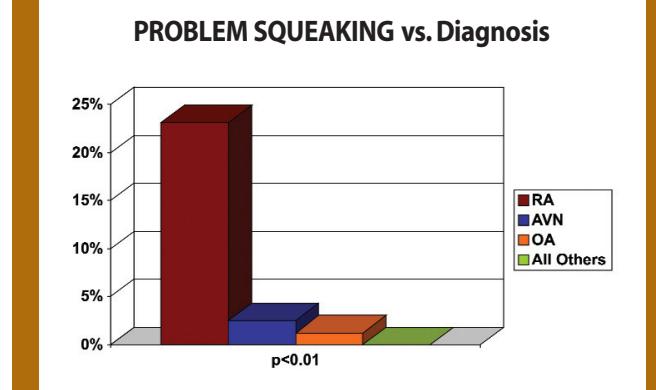
FREQUENCY GRADE BY ACETABULAR IMPLANT				
Grade (1-4)	Stryker	*Plus	Encore	Wright
4: Daily	5	2	0	0
3:>4/week	1	1	0	0
2:1-4/week	1	1	2	0
1:<1/week	9	0	1	1

INCIDENCE OF SQUEAKING (ANY FREQUENCY/SEVERITY)				
Acetabular Implant	Number of Squeakers	Number of Implants	Incidence	
Stryker	16	45	35.6%	
*Plus	4	58	6.9%	
Encore	3	138	2.2%	
Wright	1	29	3.4%	
Total	24	270	8.8%

SEVERITY GRADE BY ACETABULAR IMPLANT				
Grade (1-4)	Stryker	*Plus	Encore	Wright
4: Creates Social Problem	4	0	0	0
3: Always Perceptible to Others	4	1	0	0
2: Seldom Perceptible to Others	5	2	1	0
1: Perceptible Only to Patient	3	1	2	1

INCIDENCE OF PROBLEM SQUEAKING				
Acetabular Implant	Number of Squeakers	Number of Implants	Incidence	
Stryker	5	45	11.1%	
*Plus	1	58	1.7%	
Encore	0	138	0	
Wright	0	29	0	
Total	6	270	2.2%

PROBLEM SQUEAKING was associated with three independent variables:

1. Acetabular implant (Stryker Trident)
2. Short neck length
3. Diagnosis of rheumatoid arthritis

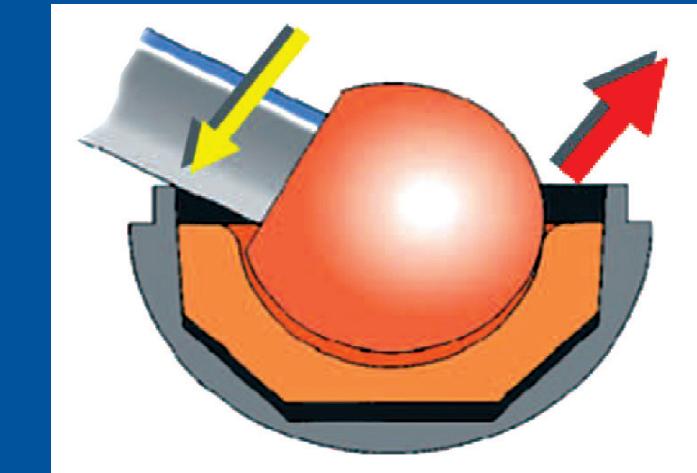
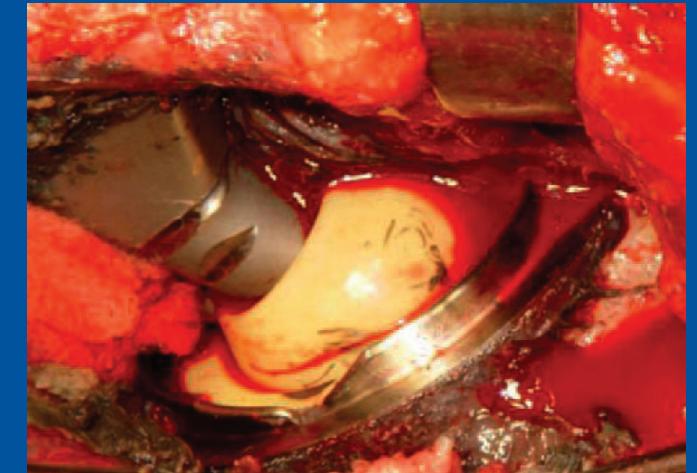
Figure 1: Levering of the femoral neck against the elevated rim resulting in damage to the acetabular rim and femoral neck (Eickmann, 2003).

Stryker's Trident acetabular component design is unique compared to the other three designs investigated in this study in that the ceramic is encased in a metal shell which extends past the rim of the ceramic to protect it from neck impingement. However, this extended rim increases the likelihood of neck impingement against the metal casing. Rim impingement may generate particulate metal debris or may result in levering of the ceramic head against the liner, either which may damage the articular surfaces and lead to squeaking (Figure 1).
