Nevada Hip & Knee
Center Of Excellence
& Research Institute

Ceramic-on-Ceramic THA: The Good with the Bad

Todd V. Swanson, MD
Las Vegas, Nevada

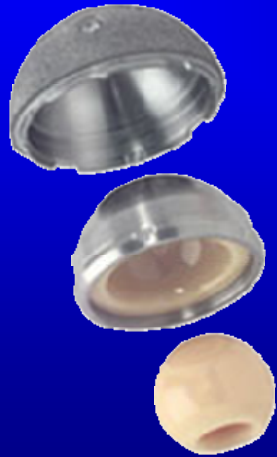
Stryker Trident cup

- Ceramic encased in metal shell which extends past ceramic face

Almost all studies with large numbers of squeaky ceramic hips are Stryker Trident cups mated with Stryker Accolade Stems

- **Something related to elevated rim ceramic inlay (Trident) and TMFZ beta titanium alloy (Accolade) leads to an unusually high incidence of squeaking**
